FIELD INVESTIGATION REPORT

Site Name: Tonawanda Coke, property is located adjacent to Niagara River on River Rd.

Date of Visit: September 8, 2016

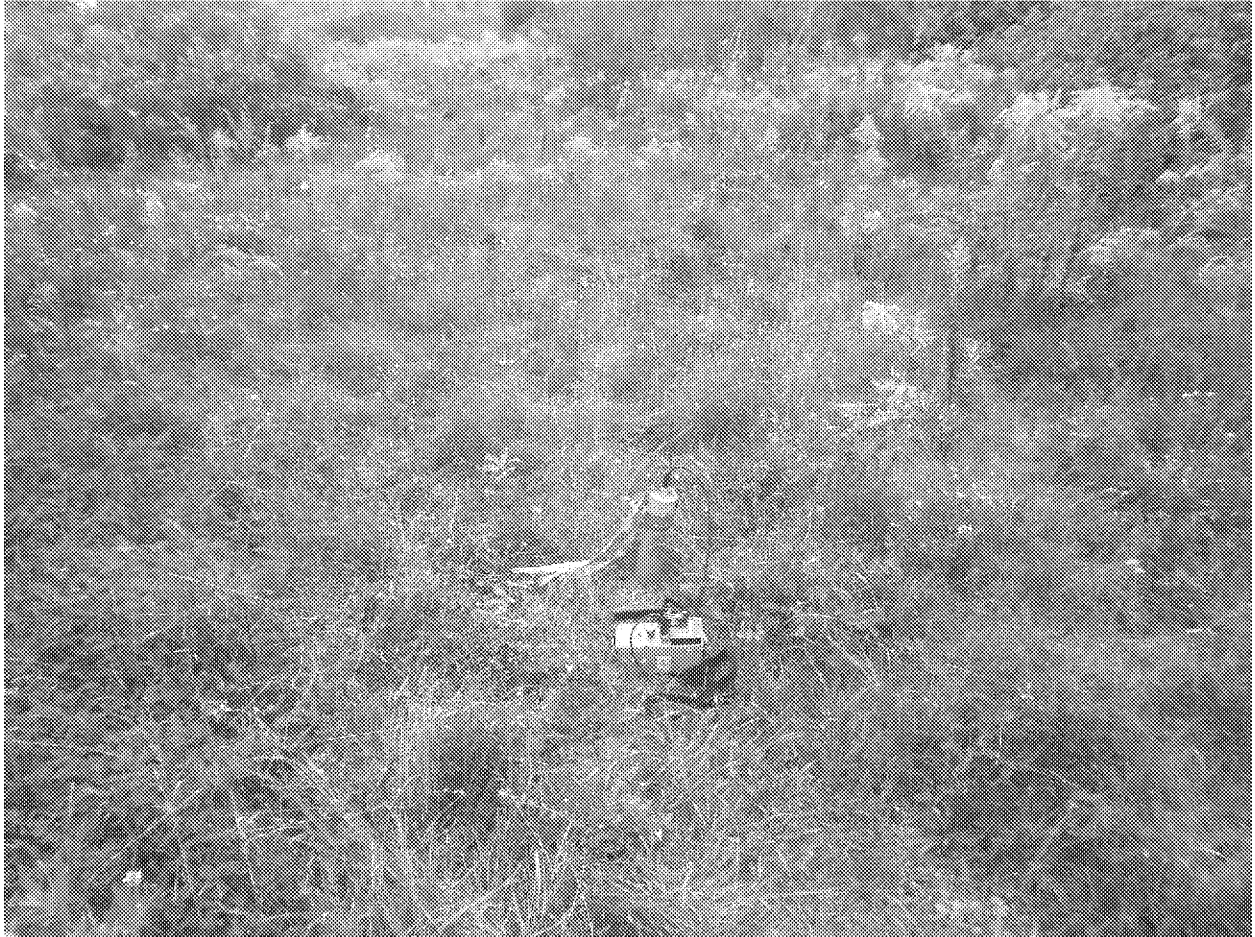
<u>Location</u>	<u>Results in Counts per Minute (CPM)</u>
Background: On property near River Rd. (Course gravel, road fill)	8,400 (1min static count, on contact)
Test Pit # 15:	
Walking up to pit:	8,000 to 11,000
Yellow bricks:	14,000
Pile of excavated material from pit:	20,000
Side walls of pit:	30,000
Dirt area around pit:	11,000
Test Pit # 3:	
Ground Surface next to pit:	10,500 (1min static count, on contact)
Side walls of pit:	23,000
Pile of excavated material from pit:	14,000
Exposed surface under coal conveyer:	17,000
Test pit #2 (scrapped area):	
Black slag:	10,000 to 14,000
White slag:	16,400 (1min static count, on contact)
Test pit # 4:	
No slag seen surface reading only: (Heavy coal tar smell in and around pit) Pit partially filled with water	5,600
Exposed slag on surface near utility poles:	10,000 to 14,000

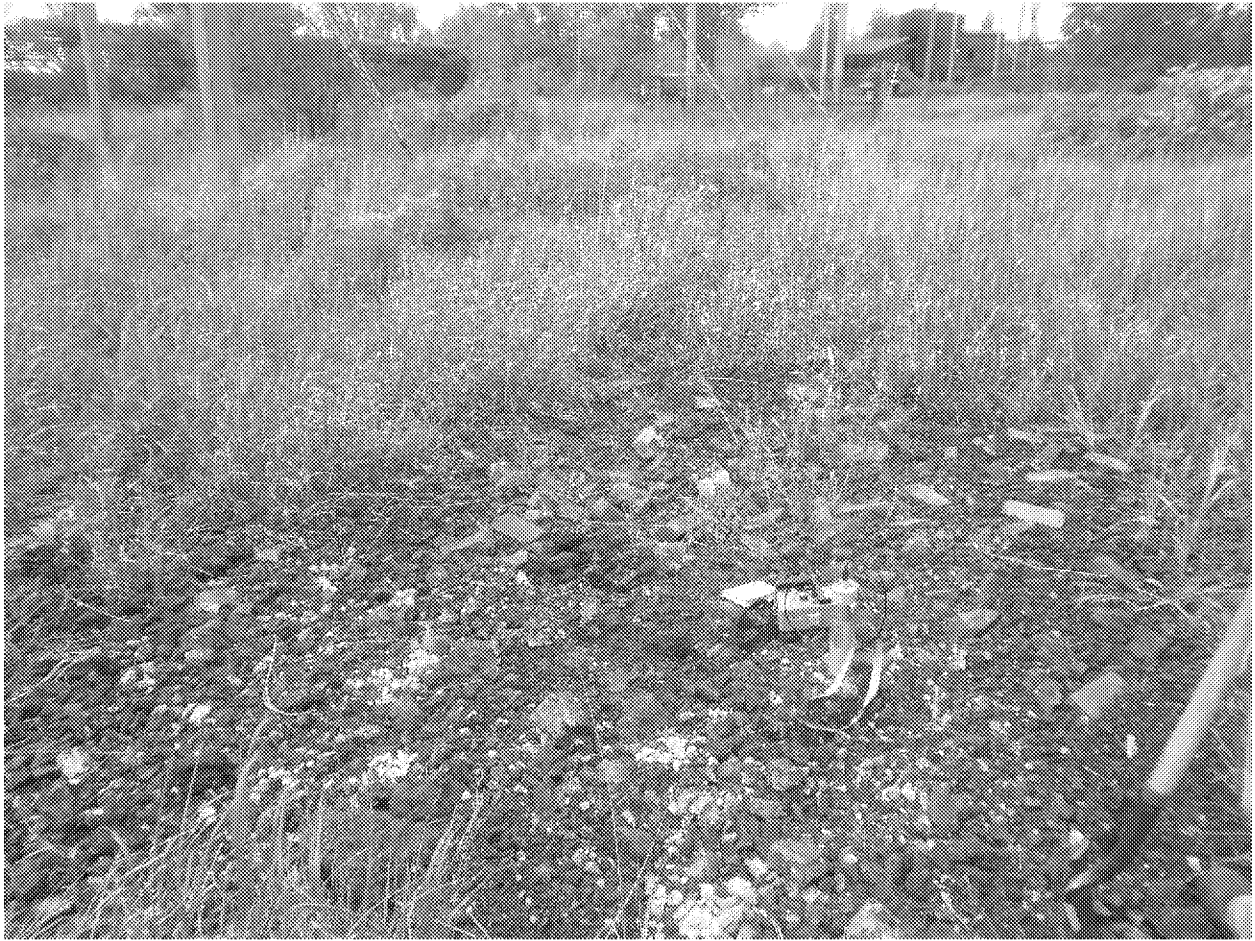
Surface Reading of exposed material:

The slag *on site* showed gamma count above background.

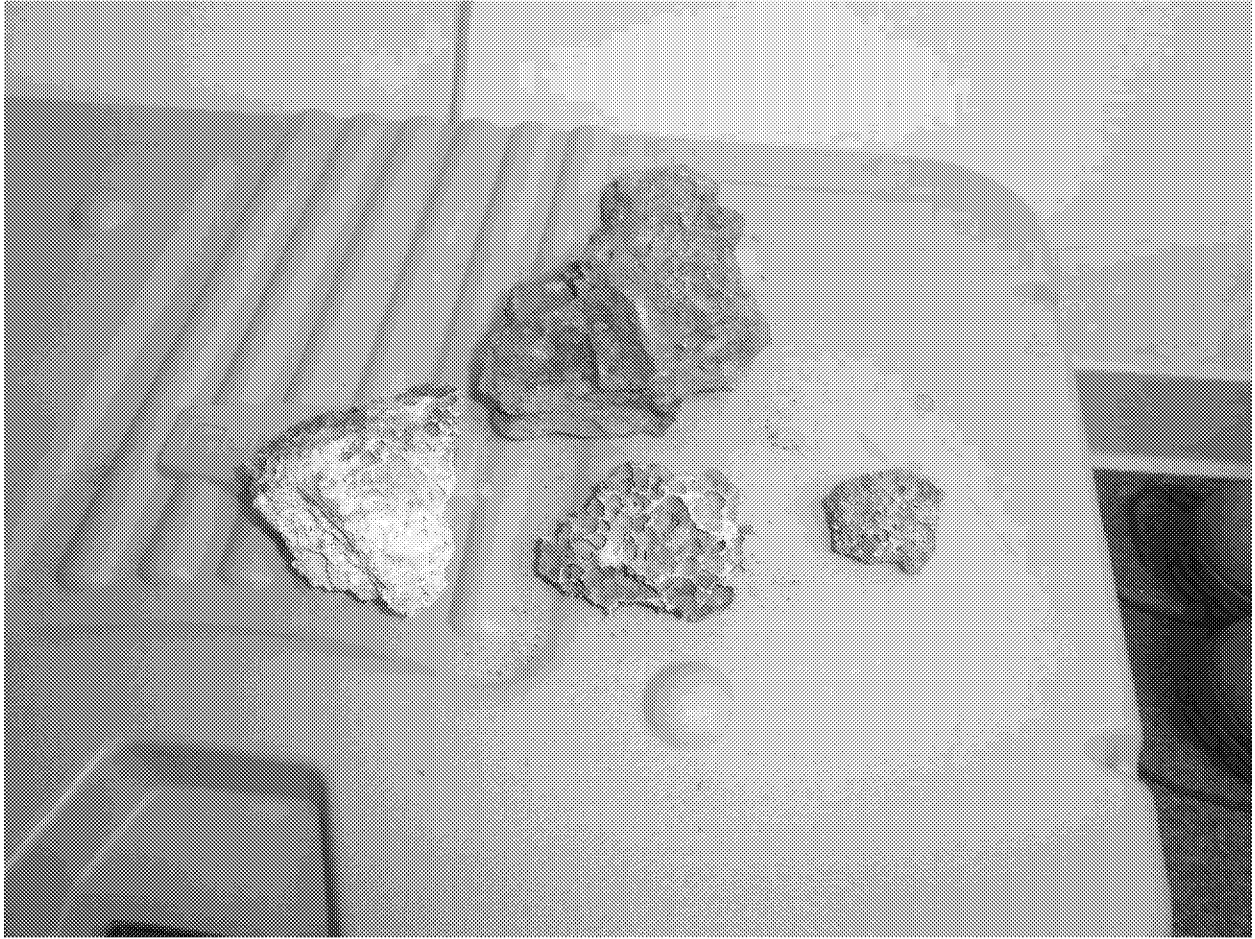
Slag material back at office:

Background at office:	5,500
Four pieces of slag together:	5,500 (no difference from bkgd)

Background at office:	35 COUNTS PER MINUTE
Four pieces of slag:	35-100 COUNTS PER MINUTE

The slag on site showed elevated counts above the one minute scaler surface and background readings. While the side walls of the pit and the piles were higher, this could be explained by the geometry in the field. The slag counted at the office with the 44-10 probe showed the counts to be at background for the office area. The pancake probe showed elevated counts. In the field the slag samples were elevated above background.
